Machinery Messages

Using ADRE® 3 to on a pressurized water

*By Marc Tompkins
Branch Manager
Bently Nevada Corporation
Pittsburgh, Pennsylvania*

diagnose problems on reactor coolant pump

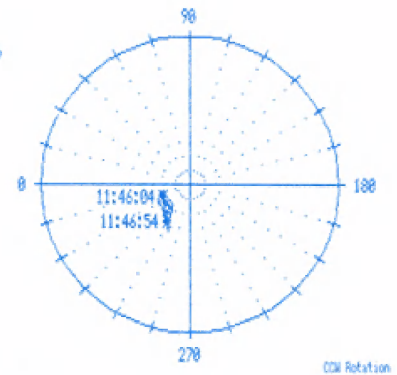
Figure 4

Machine: RCP INTERNALS CH# 1 SHAFT, HORIZ. (X)
15 JUN 88 11:46:04.3 to 15 JUN 88 11:49:04.3 Steady State IX Filtered Uncomp

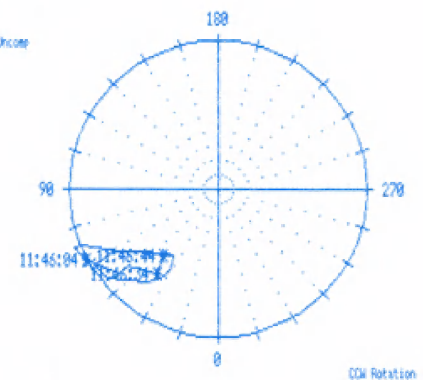
Figure 5

Machine: RCP INTERNALS CH# 2 SHAFT, VERT. (Y)
15 JUN 88 11:46:04.3 to 15 JUN 88 11:49:04.3 Steady State IX Filtered Uncomp
